**SEATTLE CITY LIGHT
VEGETATION MANAGEMENT PLAN
EASTSIDE TRANSMISSION LINE**

**CRITICAL AREAS LAND USE PERMIT
CITY OF BELLEVUE**

**SEATTLE CITY LIGHT
ENVIRONMENTAL AFFAIRS DIVISION**

JANUARY 2021

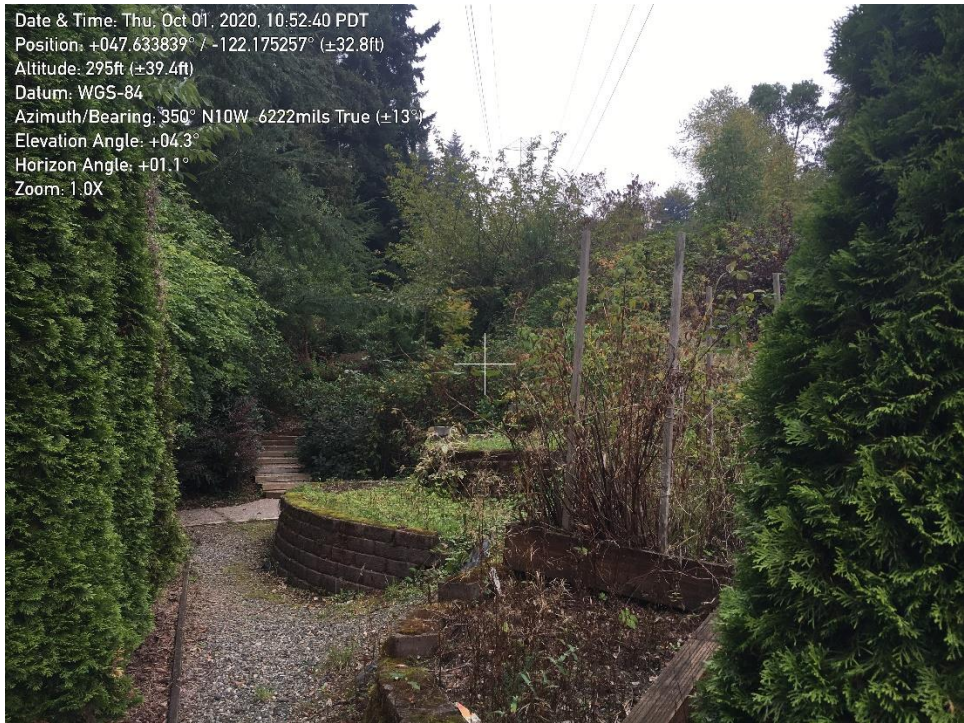
Near Tower B15/17S Looking north under lines towards tower and Douglas fir to be side trimmed at 12346 26th Pl.

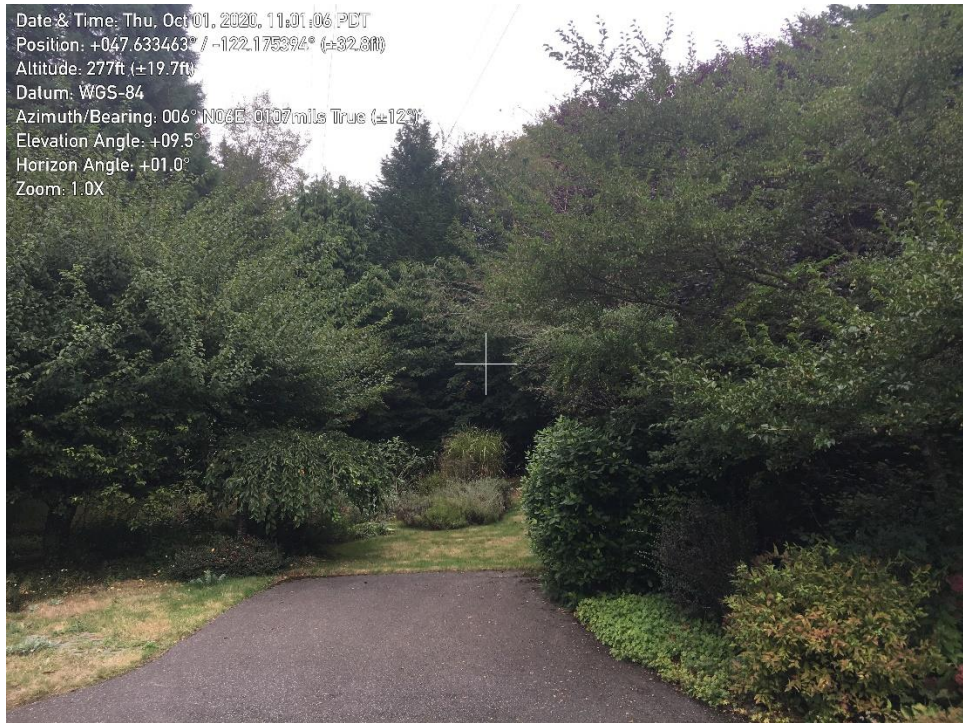
Near Tower B15/17S Looking north from the north end of NE 24th St. at fast-growing, deciduous saplings growing under lines.

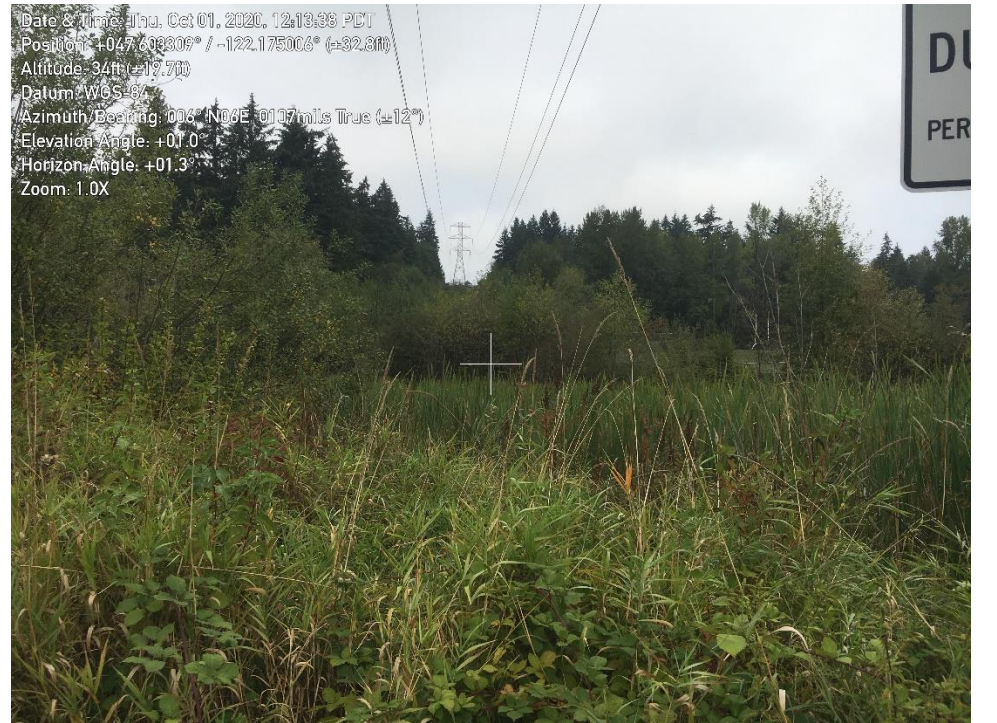
B17/15S – Lake Hills Connector Looking north at fast-growing, deciduous saplings growing under lines.

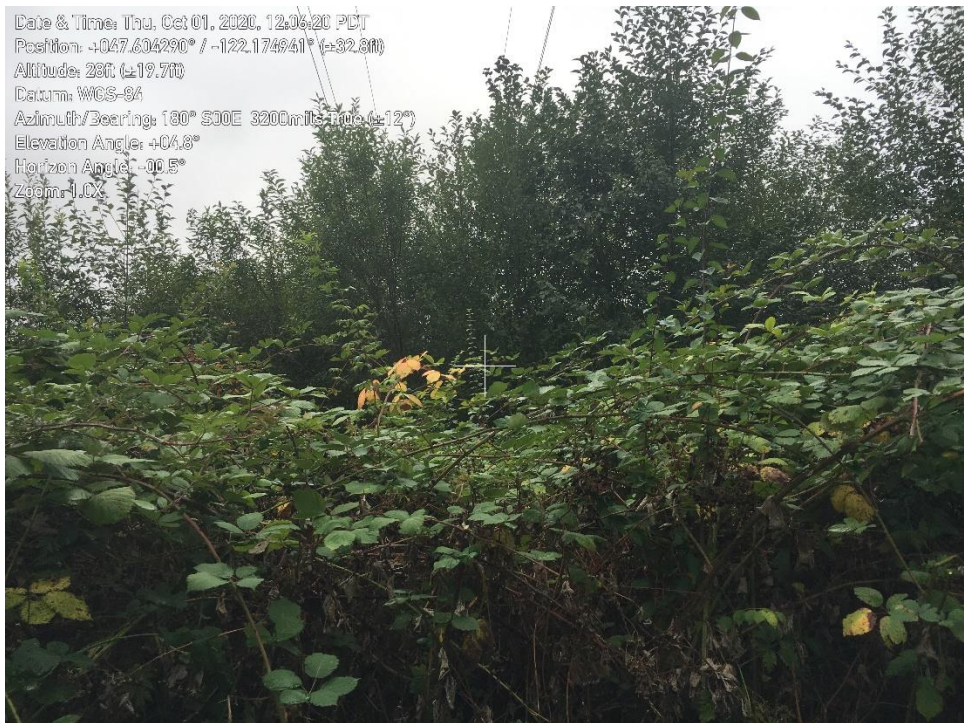
B17/15S – Lake Hills Connector Looking north at fast-growing, deciduous saplings growing under lines.

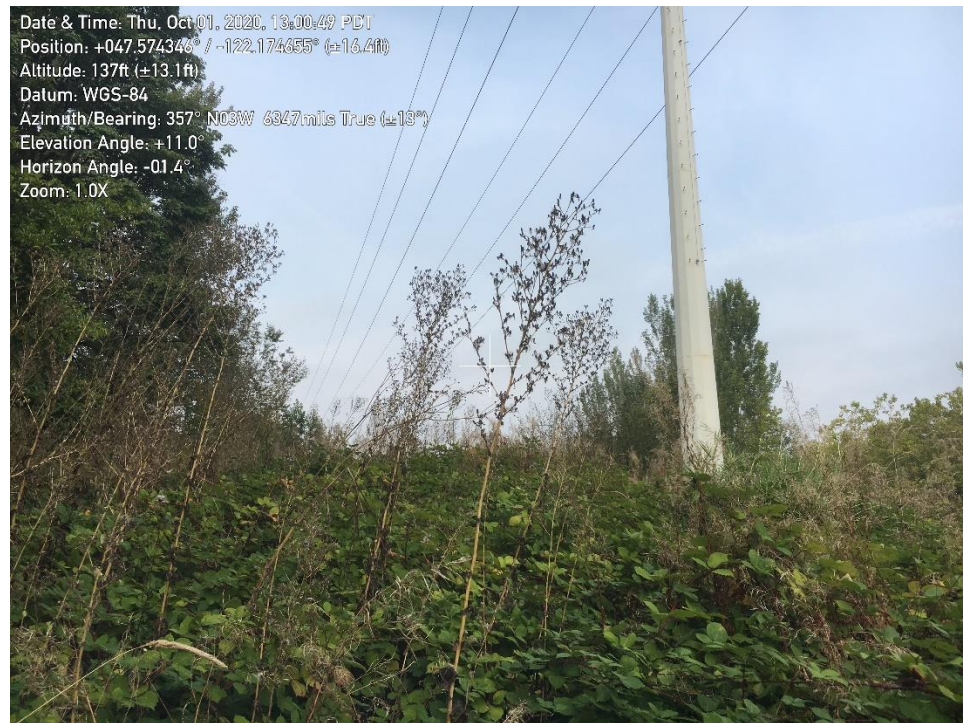
B19/28S Looking north at Himalayan blackberry along the access route to the tower.

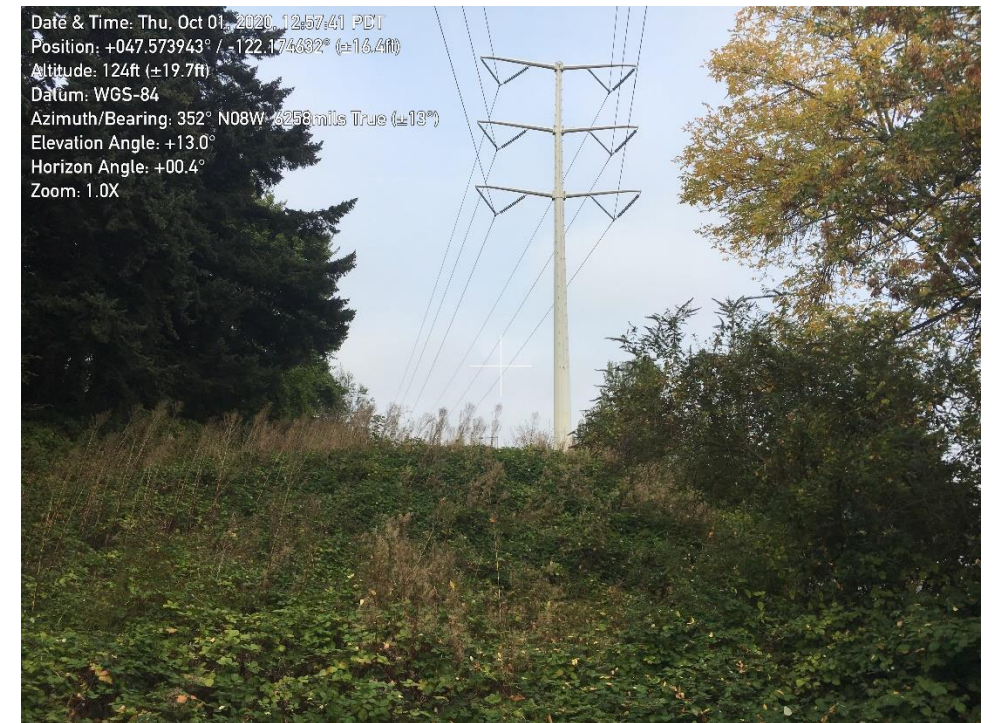
B19/28S Looking north at Himalayan blackberry and other non-native species on the access route to the tower.

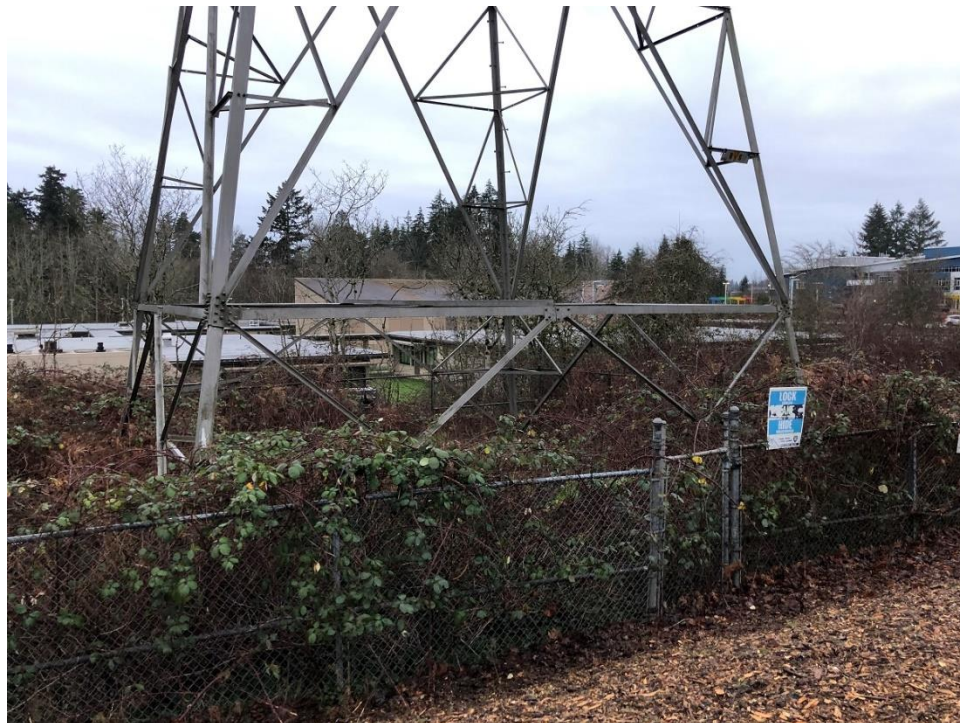
Tower B17/7S (Wilburton) Dense Himalayan blackberry to be removed from around tower.

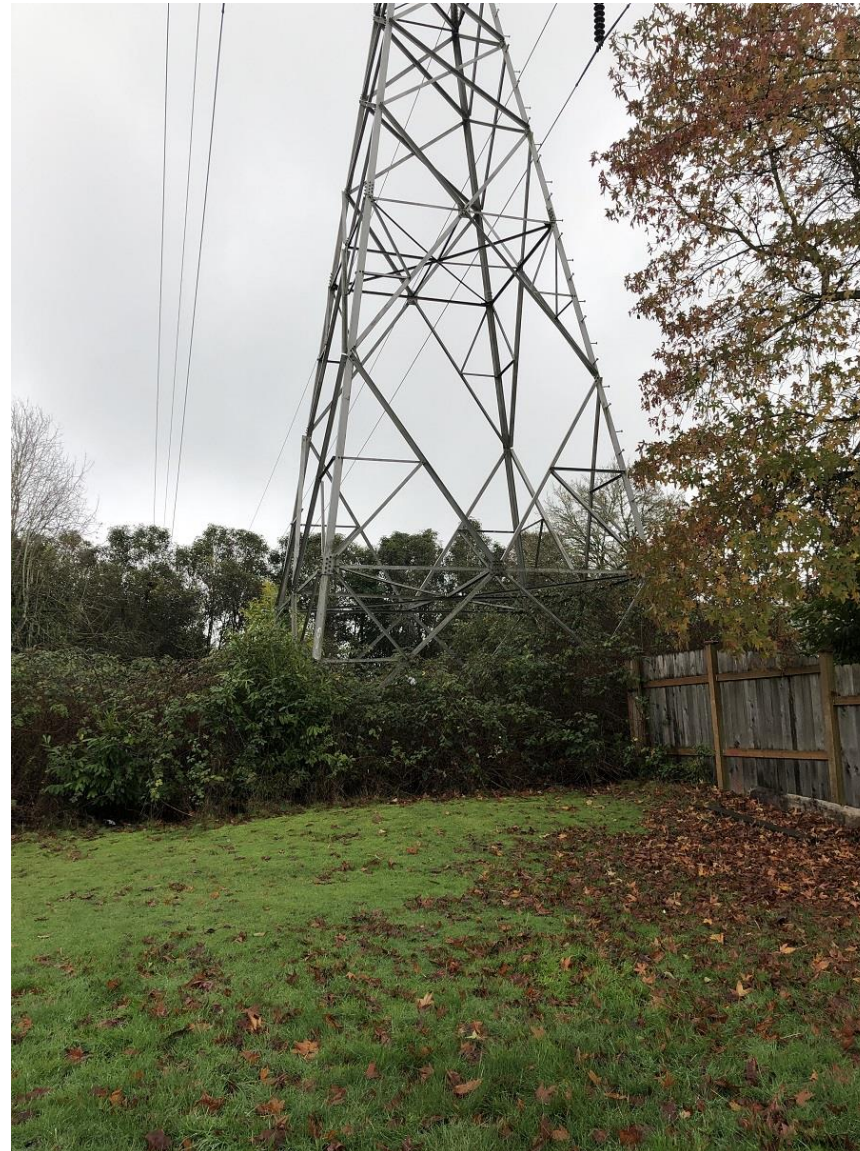
Tower B18/19S Dense Himalayan blackberry to be removed from around tower and sweetgum tree canopy reduction (left background).

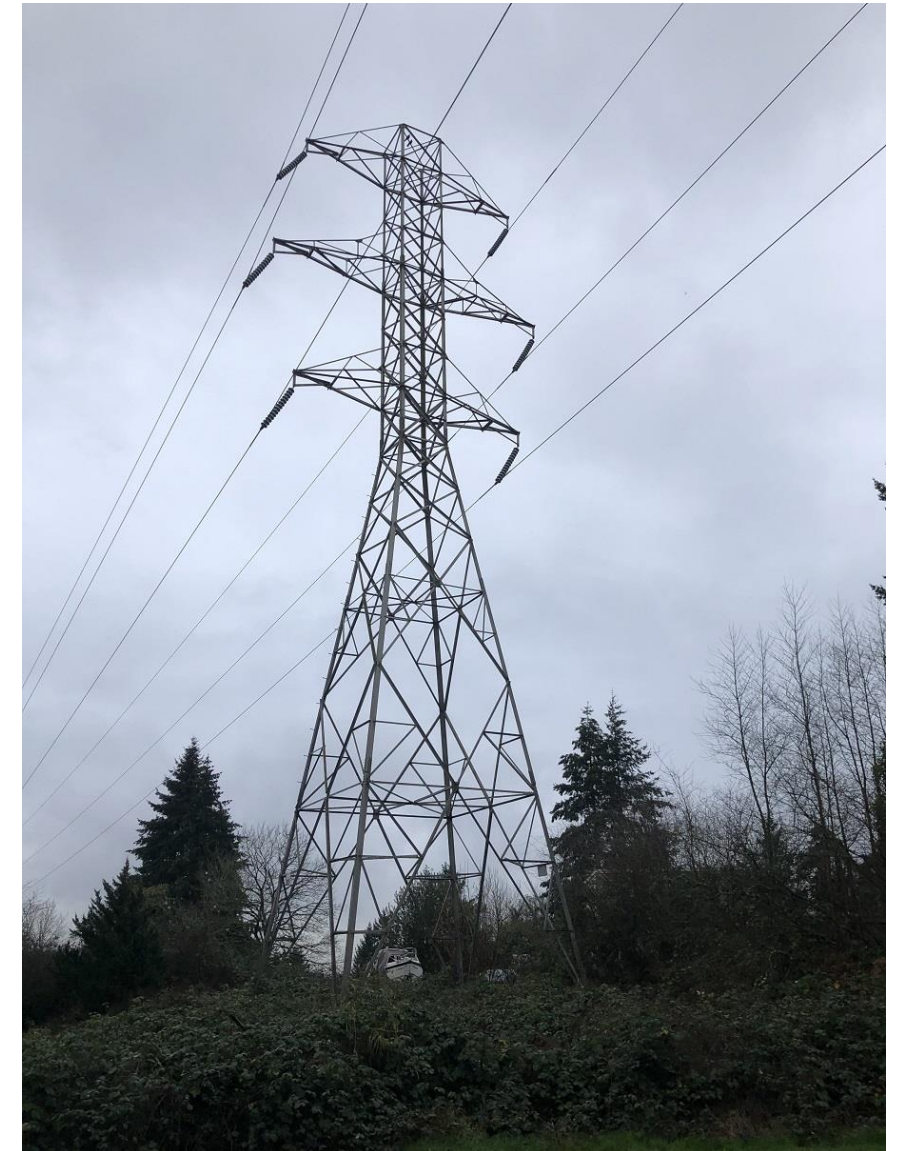
Tower B18/27S Dense Himalayan blackberry to be removed from around tower and reduce crowns of two Leyland cypress
